Service Bulletin

BKSB-1040 Issue Date 2/3/15

NOTE: THIS BULLETIN APPLIES TO THE KNG-M SERIES AND KAA0660

Issue: The key ring on Hirose connector of the KAA0290 and KAA0276 is breaking.

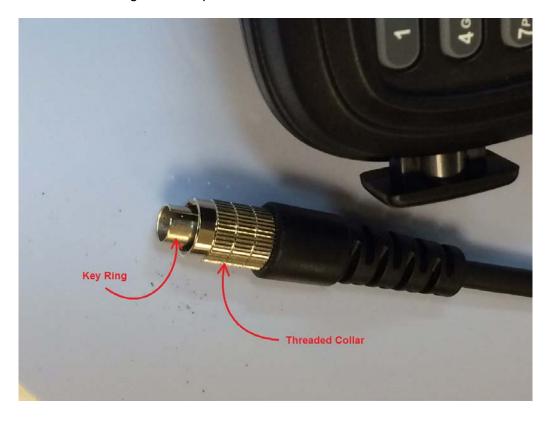
There has been isolated cases where the 'key ring' of the connector is being sheared-off or damaged if the connector is mated to the radio's microphone connector without securely fastening the 'threaded collar'. The 'key ring' was designed to guide the connector, and the threaded collar is used to secure the connector; therefore, the collar must be secured to the mating threads before using the microphone.

Recommended Action: To reduce the risk of damaging the connector, inform the end user to securely fasten the threaded collar of the connector before using the microphone.
