Service Bulletin

BKSB-1080
Issue Date: 12/08/2022

Issue: Resolves the potential of the “Zone” not maintaining its set location after a power cycle.

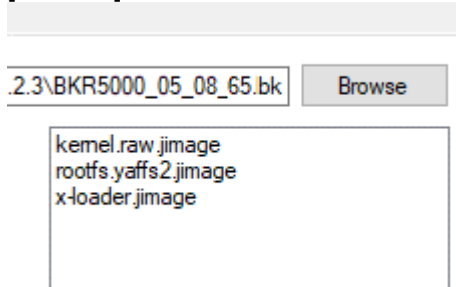
4. Select the “.bk” file. Three files should be shown in the source file box just below the [Browse] button:

2. Execute the Lightning Firmware Load application.
3. Select the [Browse] button and navigate to the directory where the Firmware File (.bk extension) is located.
